Stevedore fatality on board *Tasmanian Achiever*

Webb Dock, Melbourne, Victoria | 20 May 2014

ATSB Transport Safety Report
Marine Occurrence Investigation
309-MO-2014-004
Final – 2 September 2014

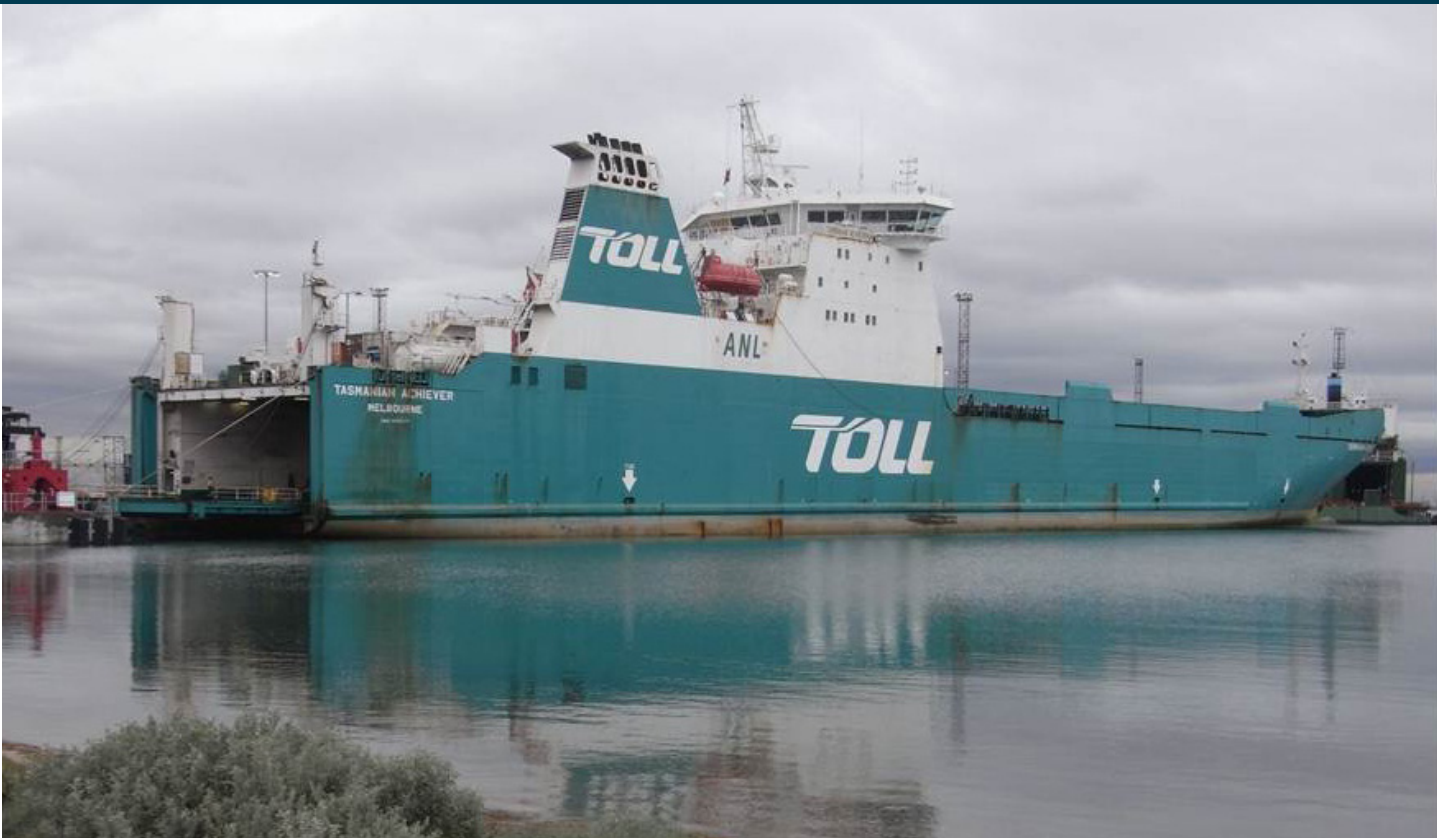
Cover photo: ATSB

At about 0700¹ on 20 May 2014, the 184 m general cargo roll-on/roll-off ship *Tasmanian Achiever* (cover) berthed at Webb Dock, Melbourne. Cargo discharge began shortly afterwards and was completed at about 1200. Back loading of the ship's main vehicle deck began shortly afterwards.

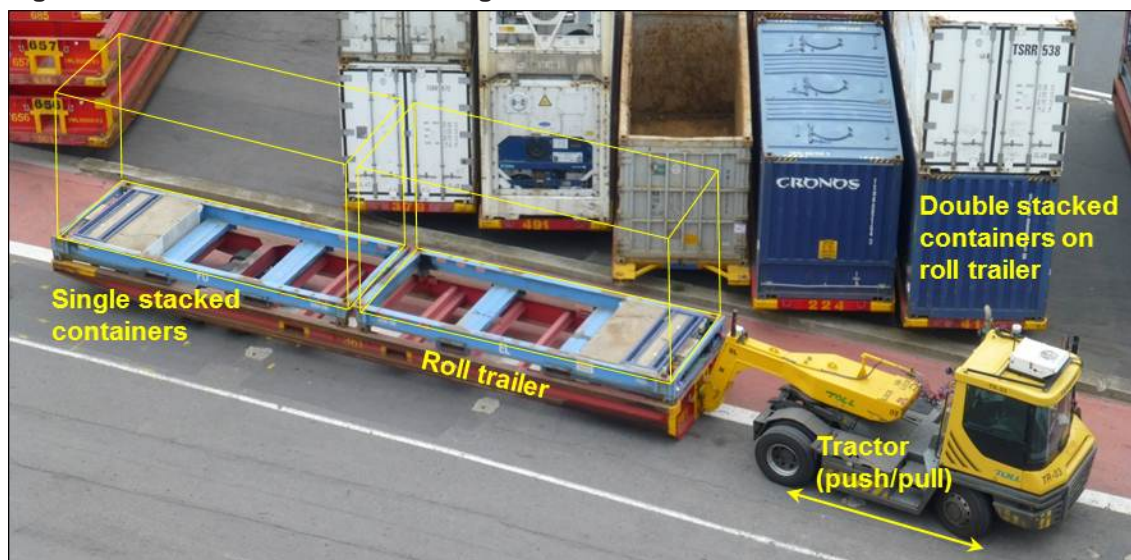
Figure 1: Roll trailer and tractor configuration

Three single stacked roll trailers (Figure 1) were loaded at the port forward end of the weather deck via the aft port side ramp. Each was driven into position by a rear mounted prime mover (tractor).

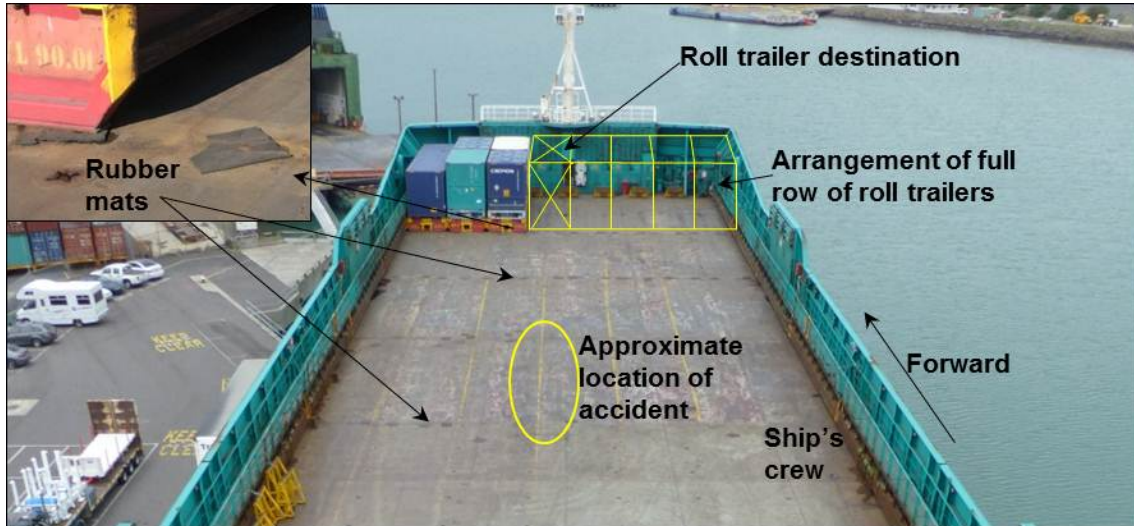
Figure 2: Weather deck layout at time of accident (inset showing use of rubber mats under roll trailer foot)

As the next roll trailer was driven up the ramp to the weather deck, the stevedore picked up some mats that he needed to position on the deck. Then, as the trailer came on the deck and aligned with the next vacant slot alongside the already loaded trailers (Figure 2), the stevedore moved towards the area in which he was going to position the mats. This location was in the path of the trailer and not visible to the tractor driver.

The ship's crew members could see the stevedore moving towards them and assumed that he saw the approaching trailer. When they realised that the stevedore was in the direct path of the trailer, they attempted to warn him and the tractor driver, but their calls went unheard. The trailer then struck the stevedore and travelled about 13 m before the driver was advised of what had happened and he stopped the tractor.

- a review of ship loading operations to improve control of the types and flow of cargo onto and off the ship
- placed an additional stevedore on deck to improve coordination of personnel and traffic
- provided additional radios for stevedores and ship’s crew
- implemented clearly defined traffic control for vehicle entry onto deck

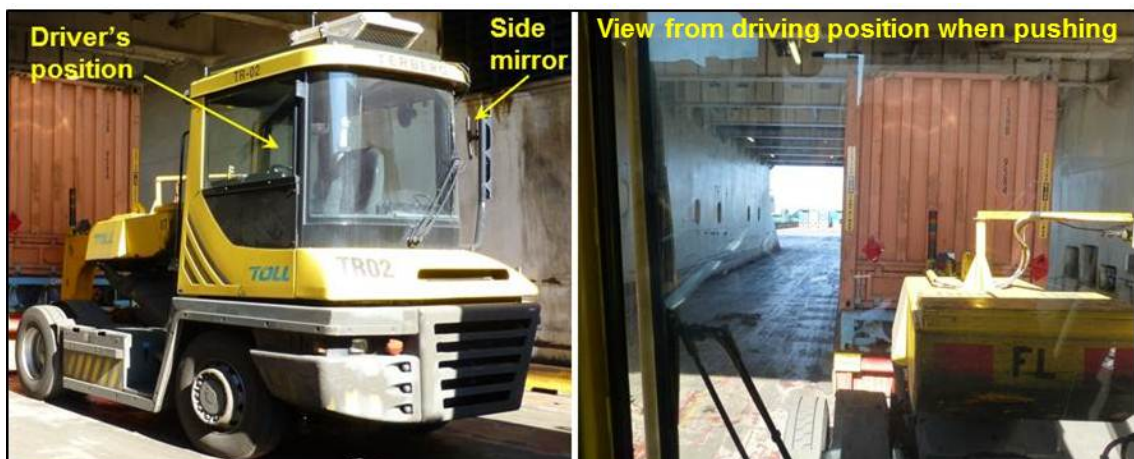
Figure 3: Tractor and driver's perspective

It was normal for loaded roll trailers to be pushed by the tractor onto the ship for loading onto the forward end of the weather deck. In this configuration, the driver's view ahead was restricted by the containers on the trailer (Figure 3). The driving position allowed for a clear view along the left hand side of the load but almost no visibility down the right hand side. The tractor was fitted a rear view mirror, but in the push configuration this mirror was positioned behind the driver and, hence, provided no assistance.
