33 tons of marble dropped! Cause of Hualien Port worker's lower body fatal accident revealed

2022/07/17 10:56 Hong Pengzhou, editor in charge of Dongsen News

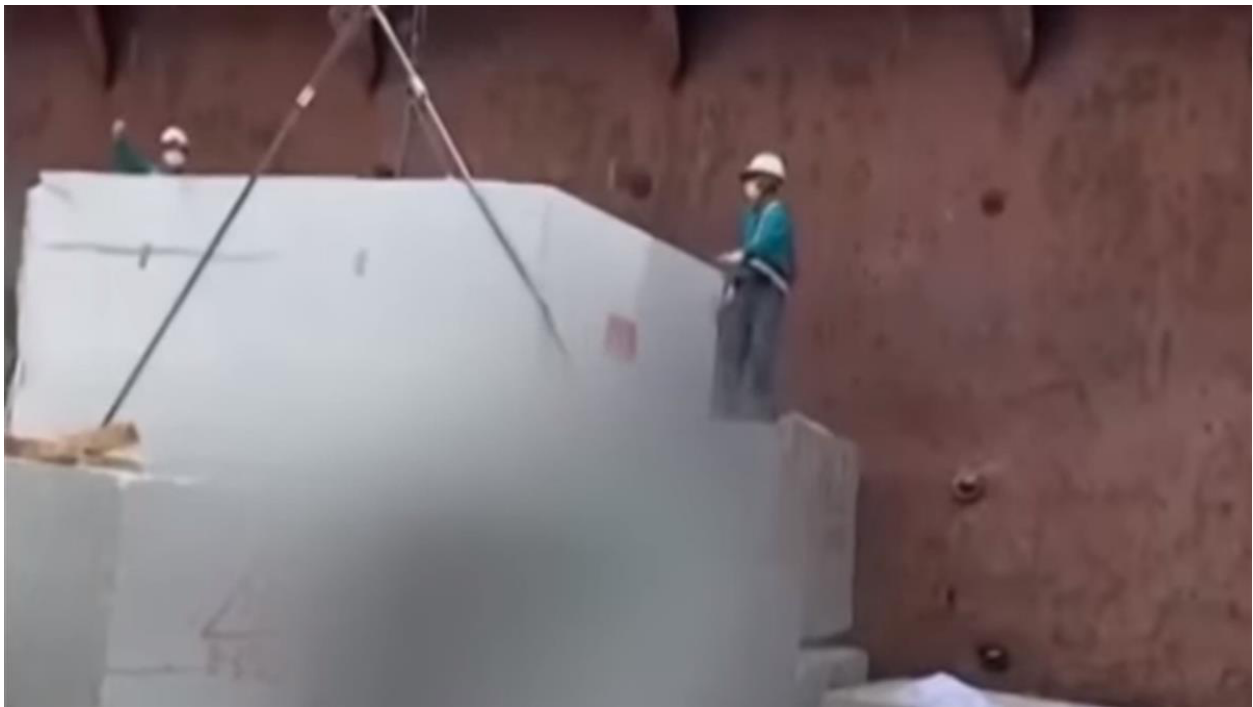
discharging blocks of marble, the cable shook and broke, and 33 tons of marble fell directly and was pressed into the ship's hold. The 63-year-old staff member surnamed Xia caused severe injuries to Xia Nan's lower body, and there was no sign of life on the spot.

Wang Paifeng, general manager of Hualien Port Branch, said that after investigation, it was found that when the unloading operation was carried out at that time, the steel cable broke due to friction against the bulkhead of the ship, which in turn caused the boulder to fall. The surnamed employee was crushed to death for failing to dodge.

In addition, Wang Paifeng said that the operation was stopped on the day of the accident, and the occupational safety unit was notified for inspection. It was found that the discharge operation must be strengthened and improved, and the SOP standard operating procedure was reviewed. The investigation by the occupational safety unit was completed the next day after the accident. At present, the prosecutor has agreed to resume work, and the unloading ship has also left the port.

Wang Paifeng emphasized that Hualien Port has asked the loading and unloading company to submit a review report, and the occupational safety unit will also supervise and improve in the future, hoping that the same incident will not happen again in the future.
